SUPPLEMENTAL SEDIMENT PROGRAM NARRATIVE

**Surface Sediment and Low Resolution Core Sampling
Locations for the Supplemental Sediment Program**
Lower Passaic River Restoration Project

Field Photograph of Ekman Dredge
Supplemental Sediment Program
Lower Passaic River Restoration Project

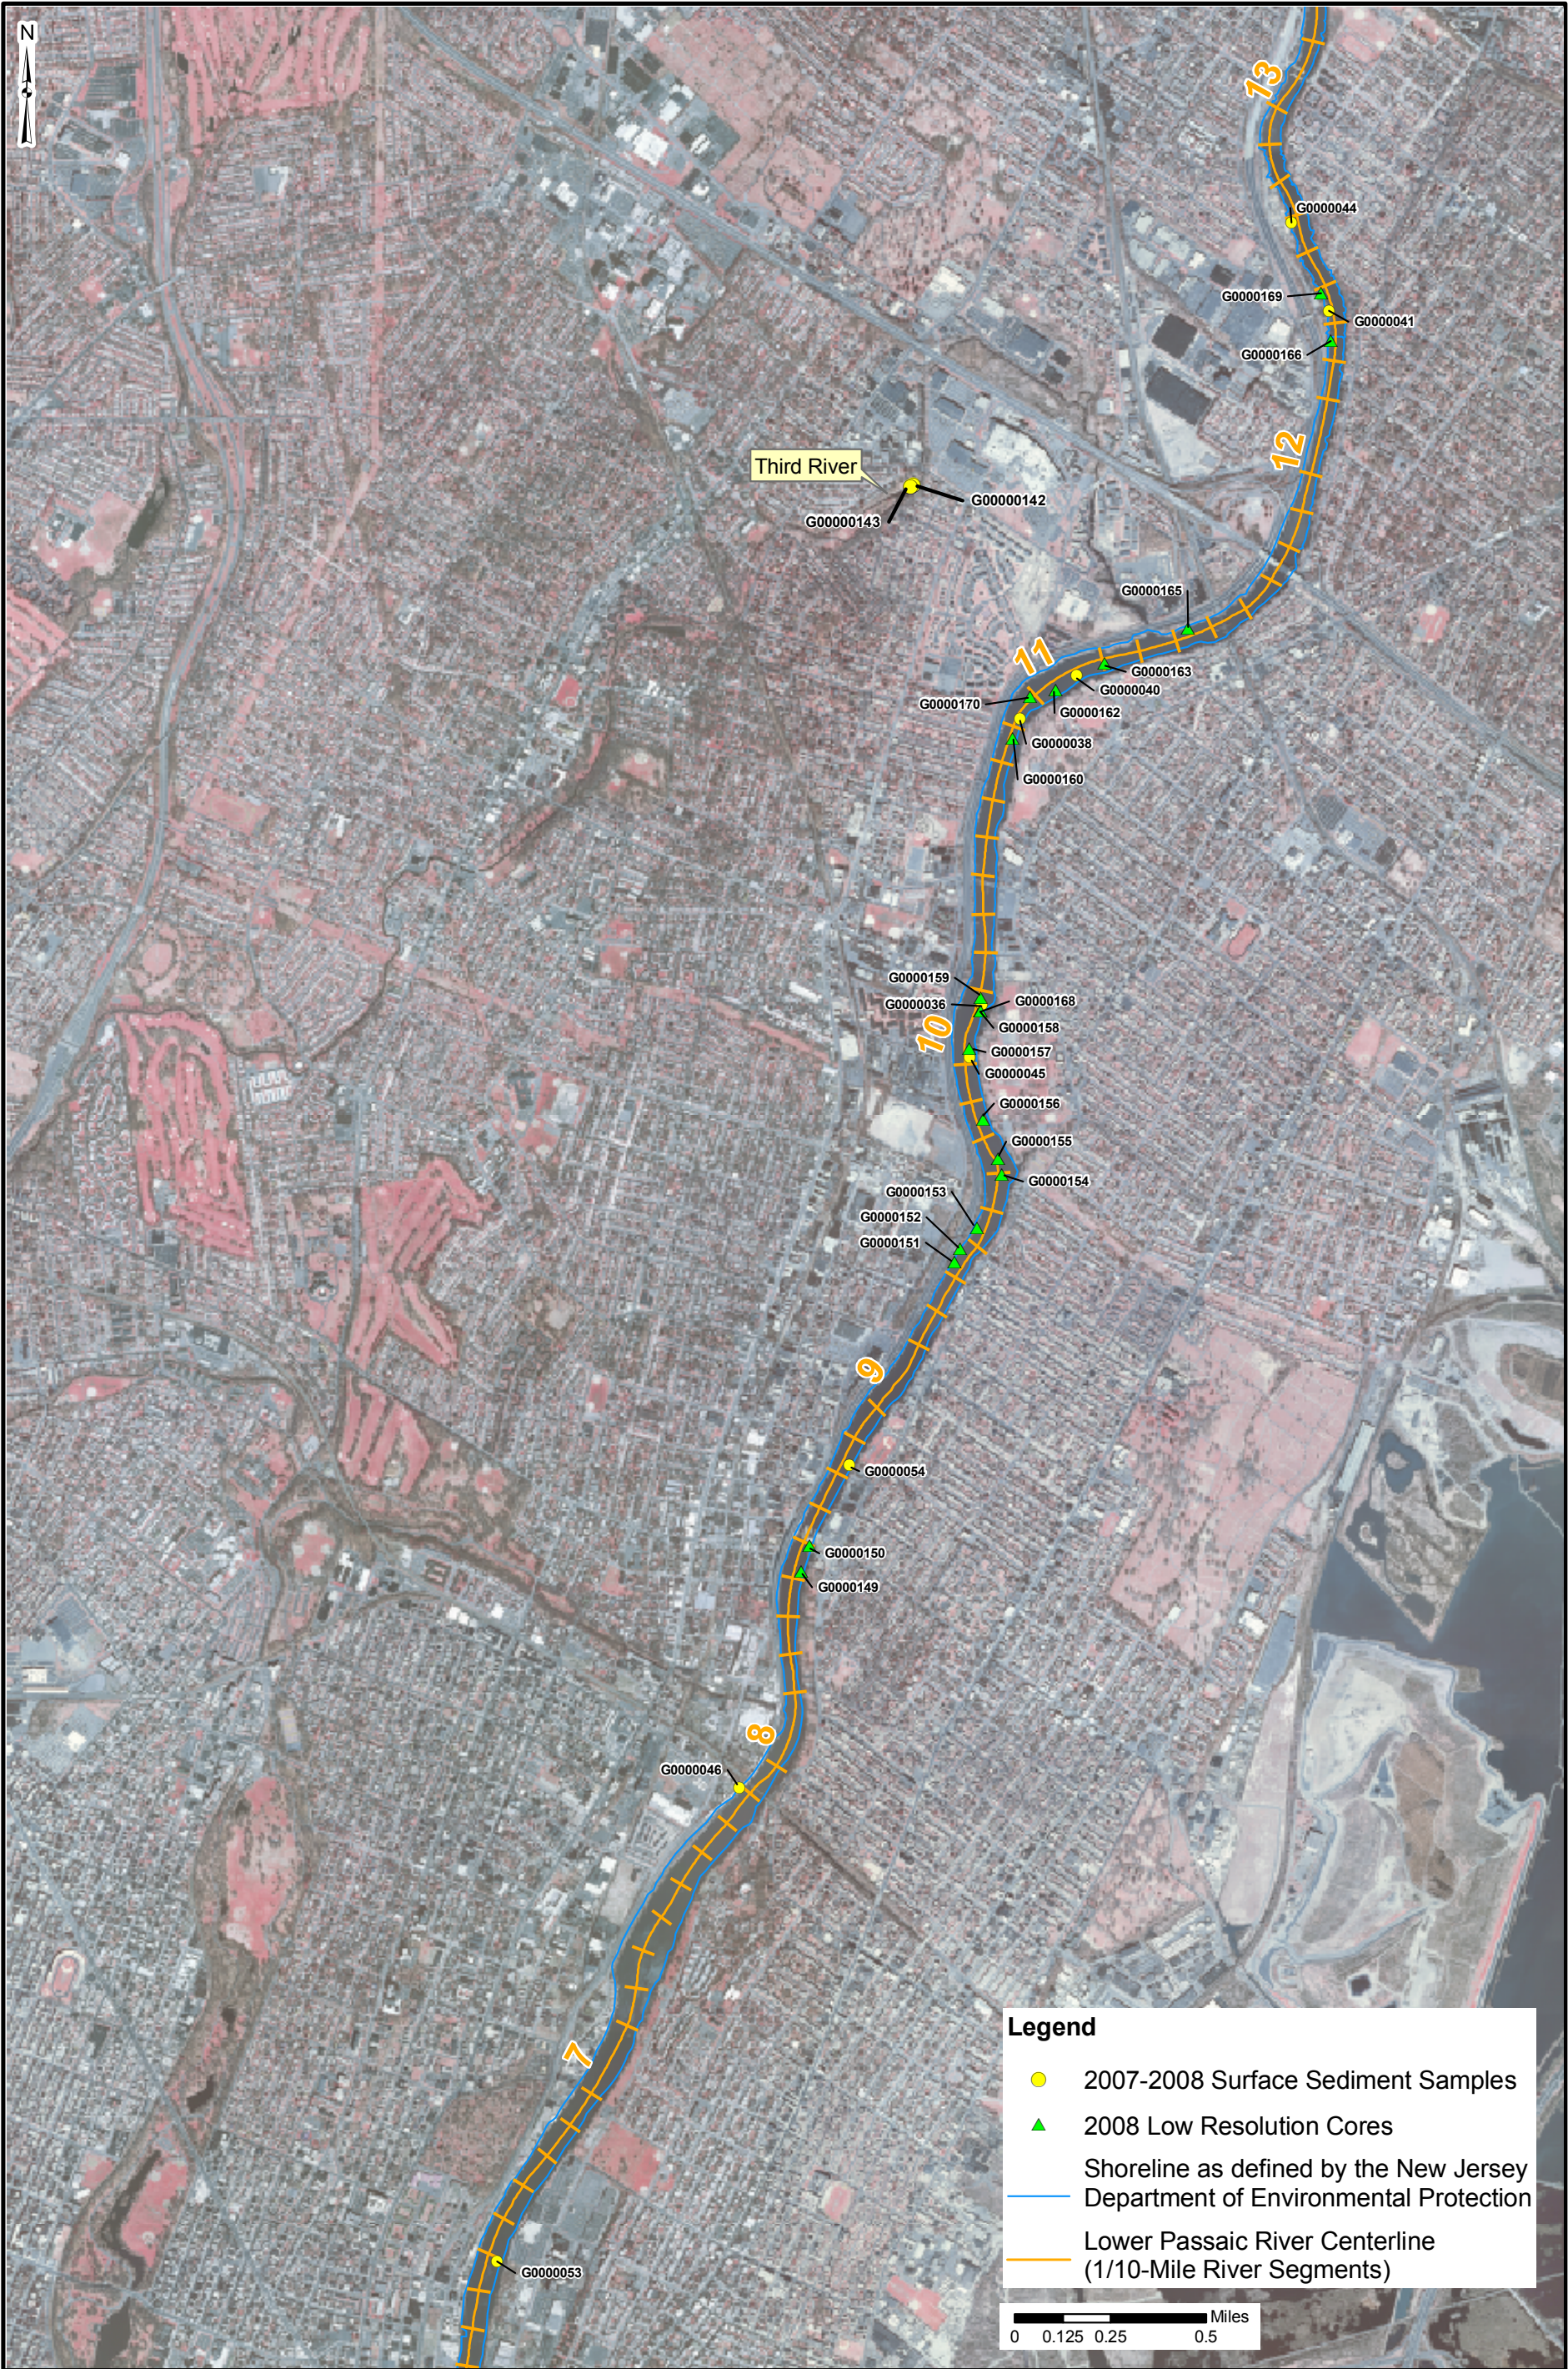
Figure 1b
November 2008

**Surface Sediment and Low Resolution Core Sampling
Locations for the Supplemental Sediment Program**
Lower Passaic River Restoration Project

Core top samples were collected from the Upper Passaic River, Lower Passaic River, Second River, Third River, and Saddle River using an Ekman dredge (Figure 1). At each location, the boat was anchored (tributary locations were accessed by wading), and the depth of the water was measured. The Ekman dredge, with polycarbonate liner and extension rods, was then advanced to the sediment surface typically to about 4-inches, where the dredge was pushed into the sediments. The dredge was tripped, closing the jaws of the dredge, and then the sediment sample within the Ekman dredge was retrieved. At the water surface, the water in the dredge was decanted off the top and the dredge was placed vertically into an aluminum lined receiving pan. Two field personnel then quickly opened the dredge and pushed it firmly flat onto the bottom of the receiving pan. The polycarbonate liner was then released from within the dredge leaving only the liner with the sediment intact in the receiving pan. A decontaminated stainless steel spatula was then used to scoop the top 1-inch of sediment into a decontaminated stainless steel bowl. The sample was homogenized in the bowl using American Society for Testing and Materials (ASTM) mixing protocols. The sample was then scooped into the appropriate sample jars for shipment to the laboratories. Refer to the QAPP/FSP Addendum SOP for more detail. A photograph of the Ekman dredge is presented in Figure 2.

Low resolution cores were collected from 23 locations on the Lower Passaic River between RM8 and the Dundee Dam (RM17.4) between January 16, 2008 and January 30, 2008 (Figure 1). Prior to core collection, three days of sediment probing was conducted in December 2007 and January 2008 (1) to field verify the sediment texture data (as interpreted from side-scan sonar images by Aqua Surveys, Inc.), (2) to locate the present day boundaries of the fine-grained sediment deposits, and (3) to locate otherwise unidentified fine-grained deposits for possible sampling.

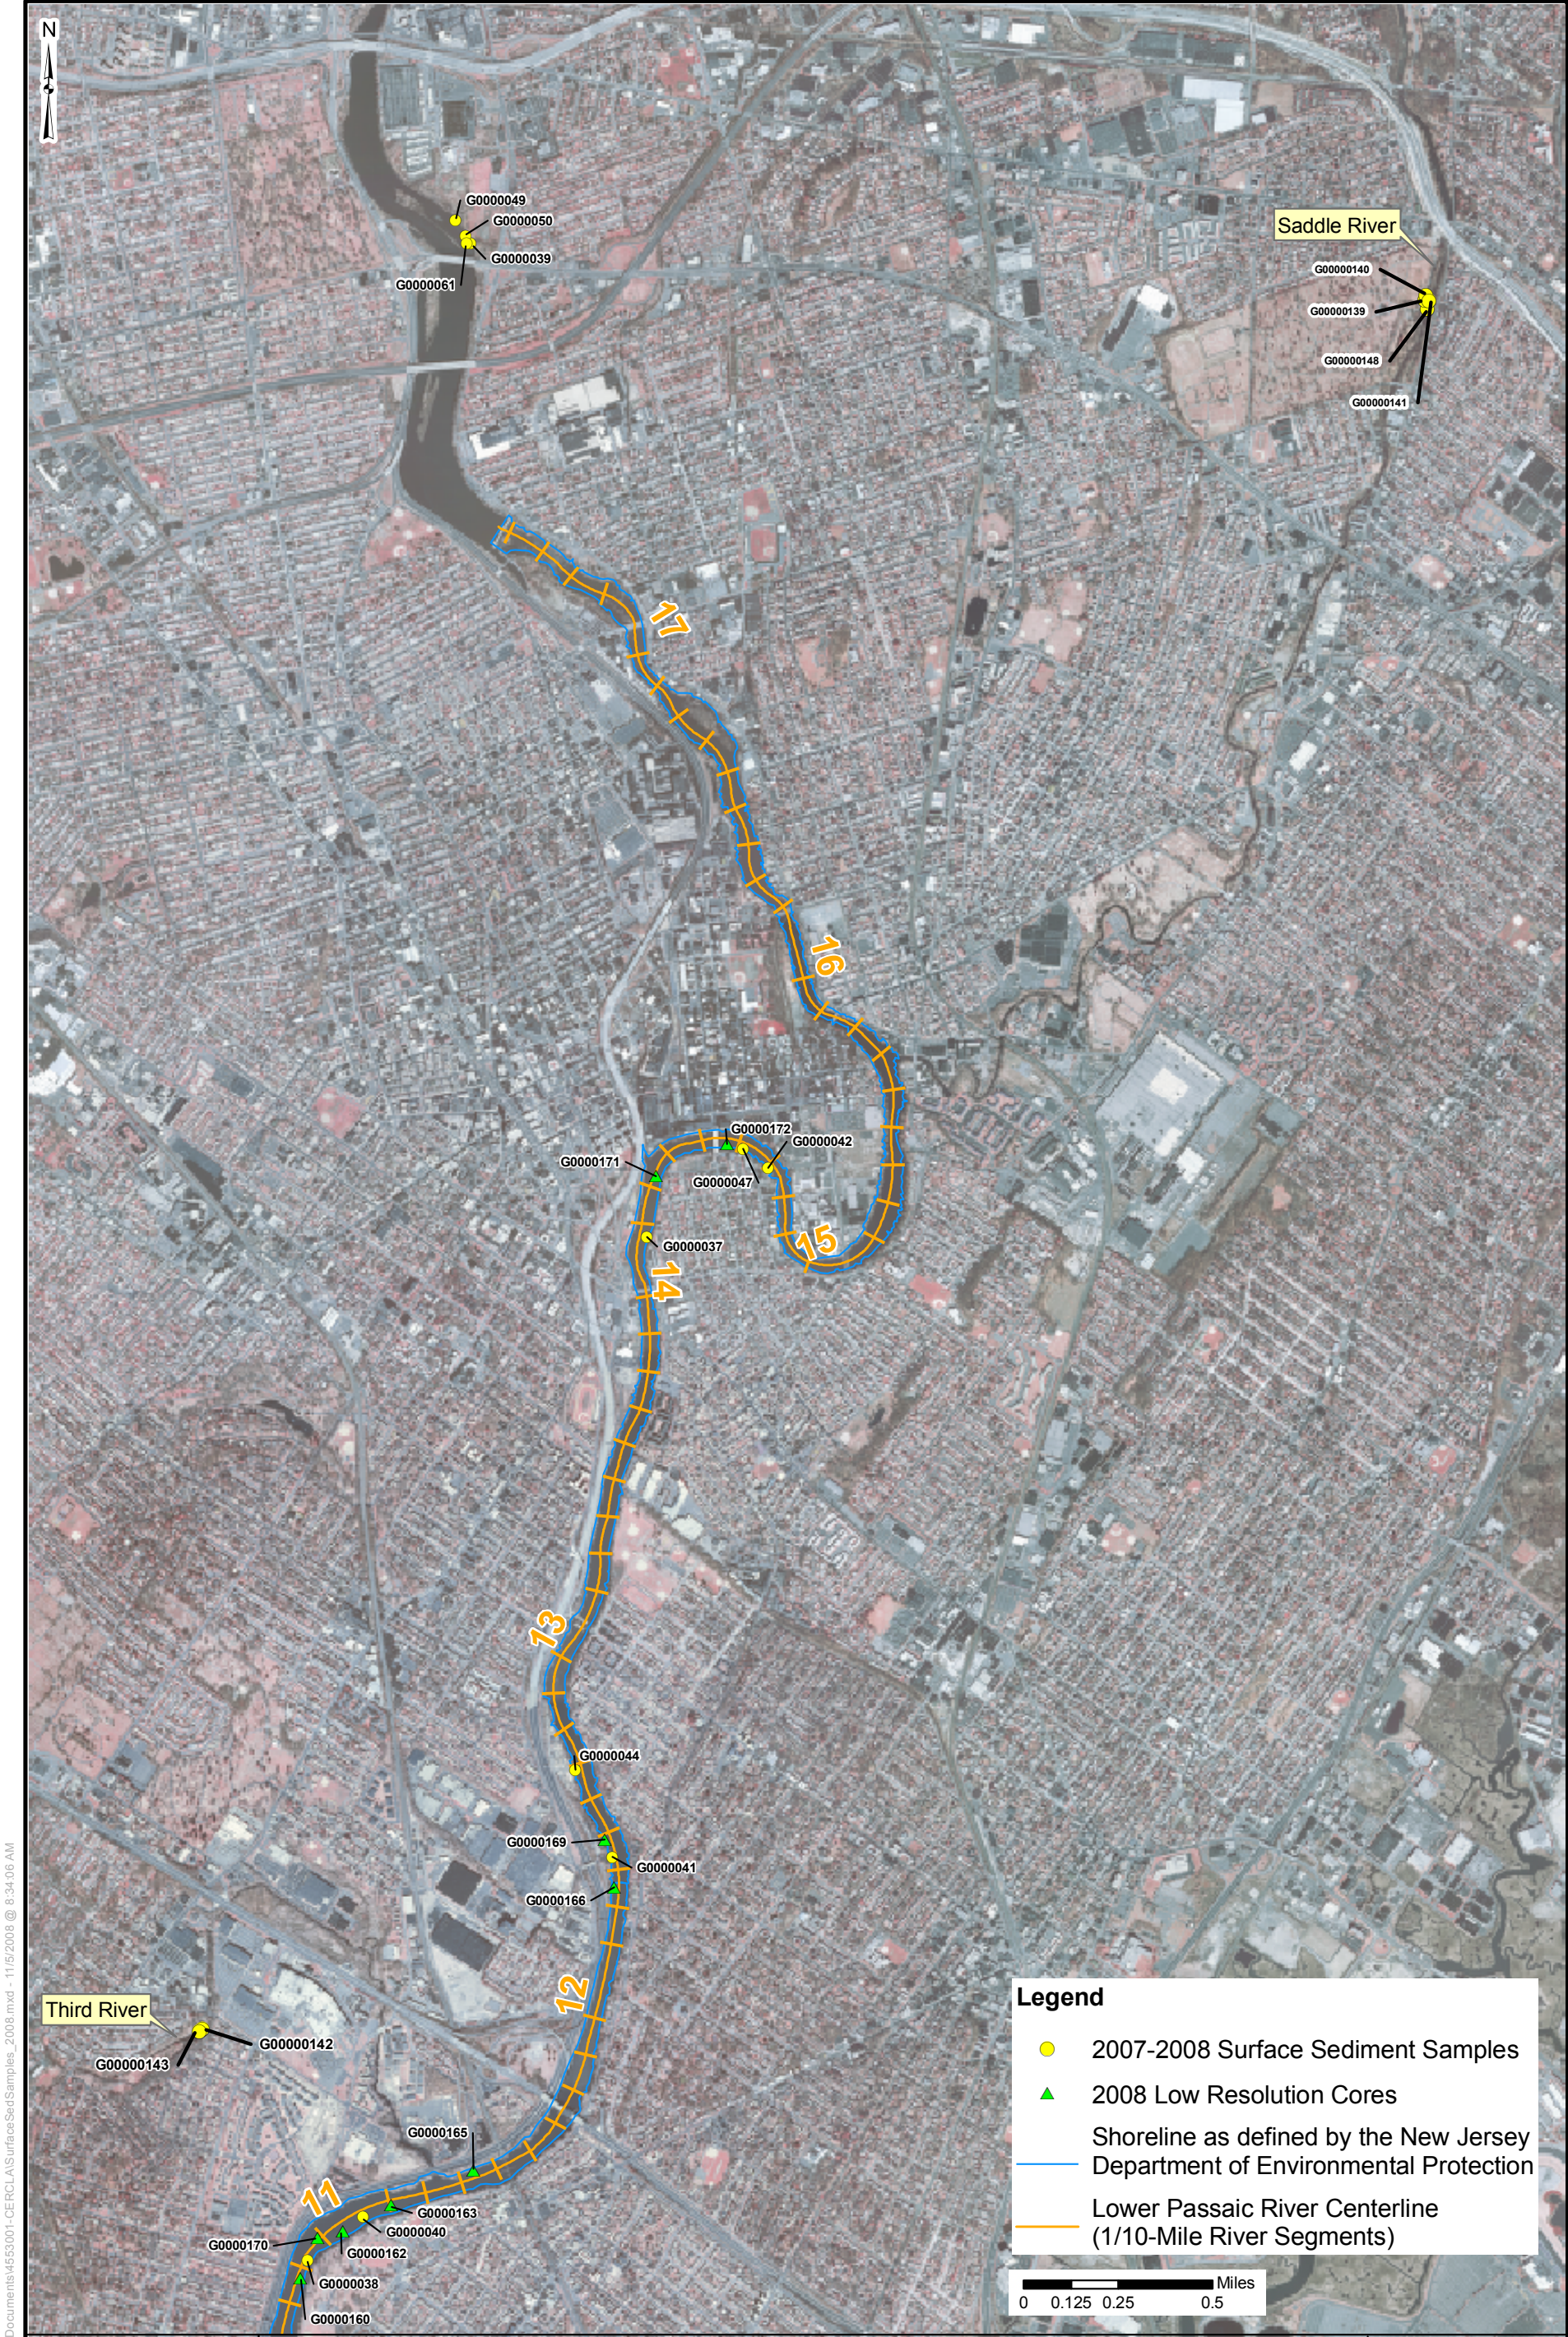
Figure 1c
November 2008

Surface Sediment and Low Resolution Core Sampling Locations for the Supplemental Sediment Program
Lower Passaic River Restoration Project

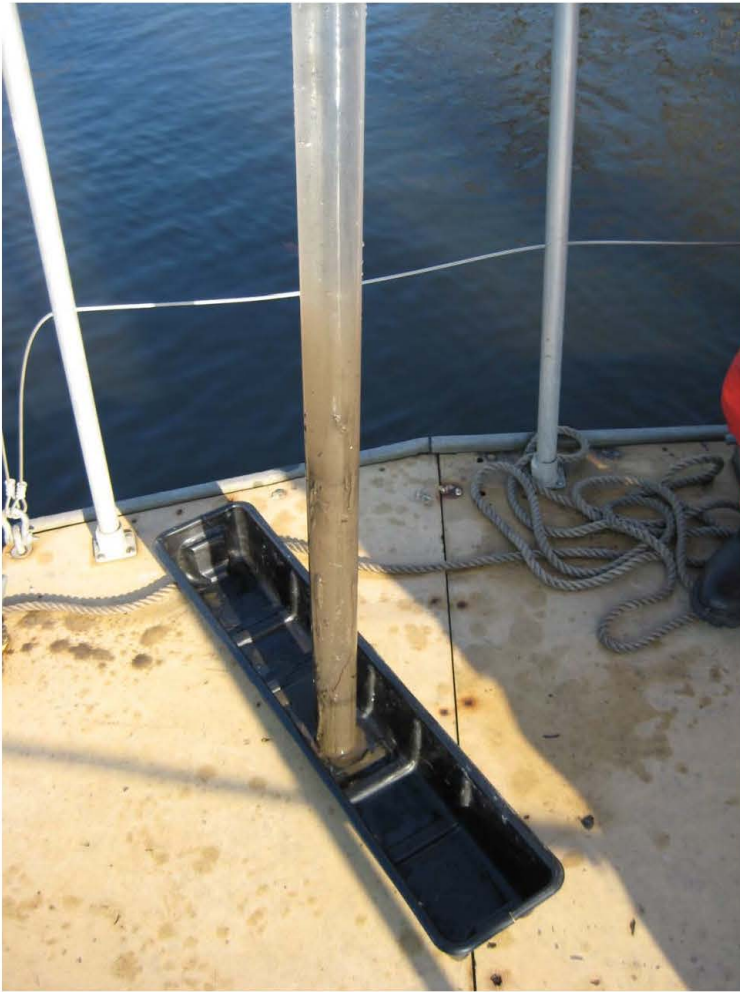
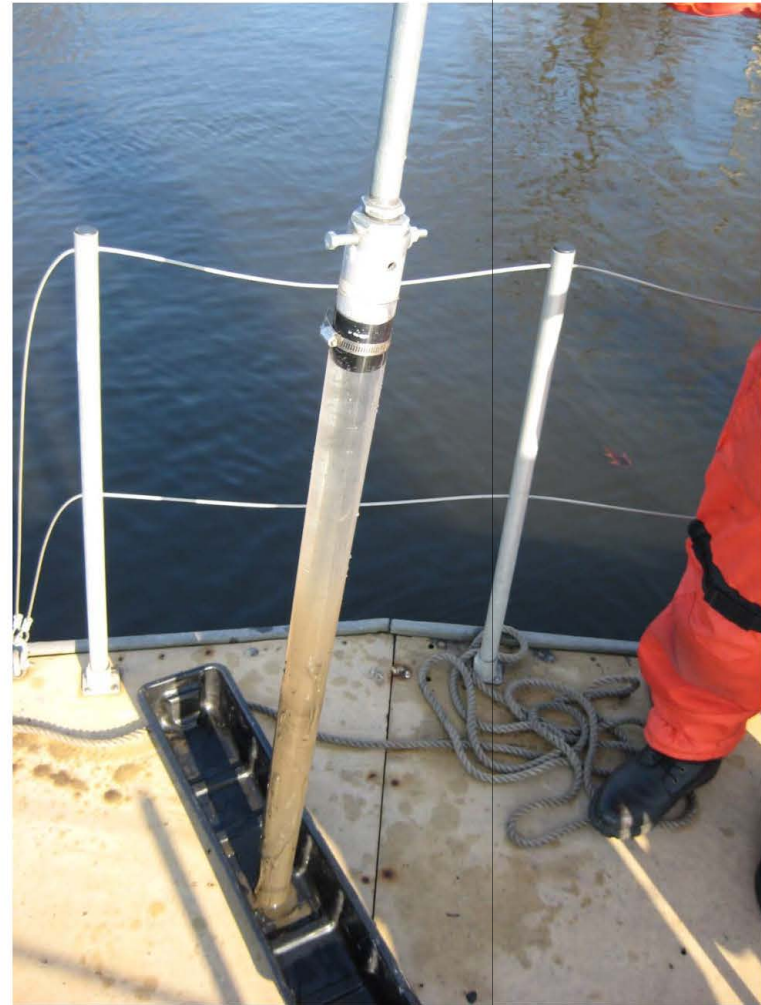
Figure 3

Field Photograph of Low Resolution Core
Supplemental Sediment Program
Lower Passaic River Restoration Project

aluminum core barrel with a soft poly liner. To retrieve the sample from the soft liner, the liner and sample was placed into a trough that would carefully contain the liner. The liner was then sliced open (longitudinally) with a decontaminated knife and the outer surface of the sediment in the liner was scraped away. A representative portion of the remaining material was placed into a decontaminated stainless steel mixing bowl, homogenized, and placed into laboratory sample containers. Refer to FSP Volume 1 SOP for more detail; a photograph of the low resolution core is presented in Figure 3.

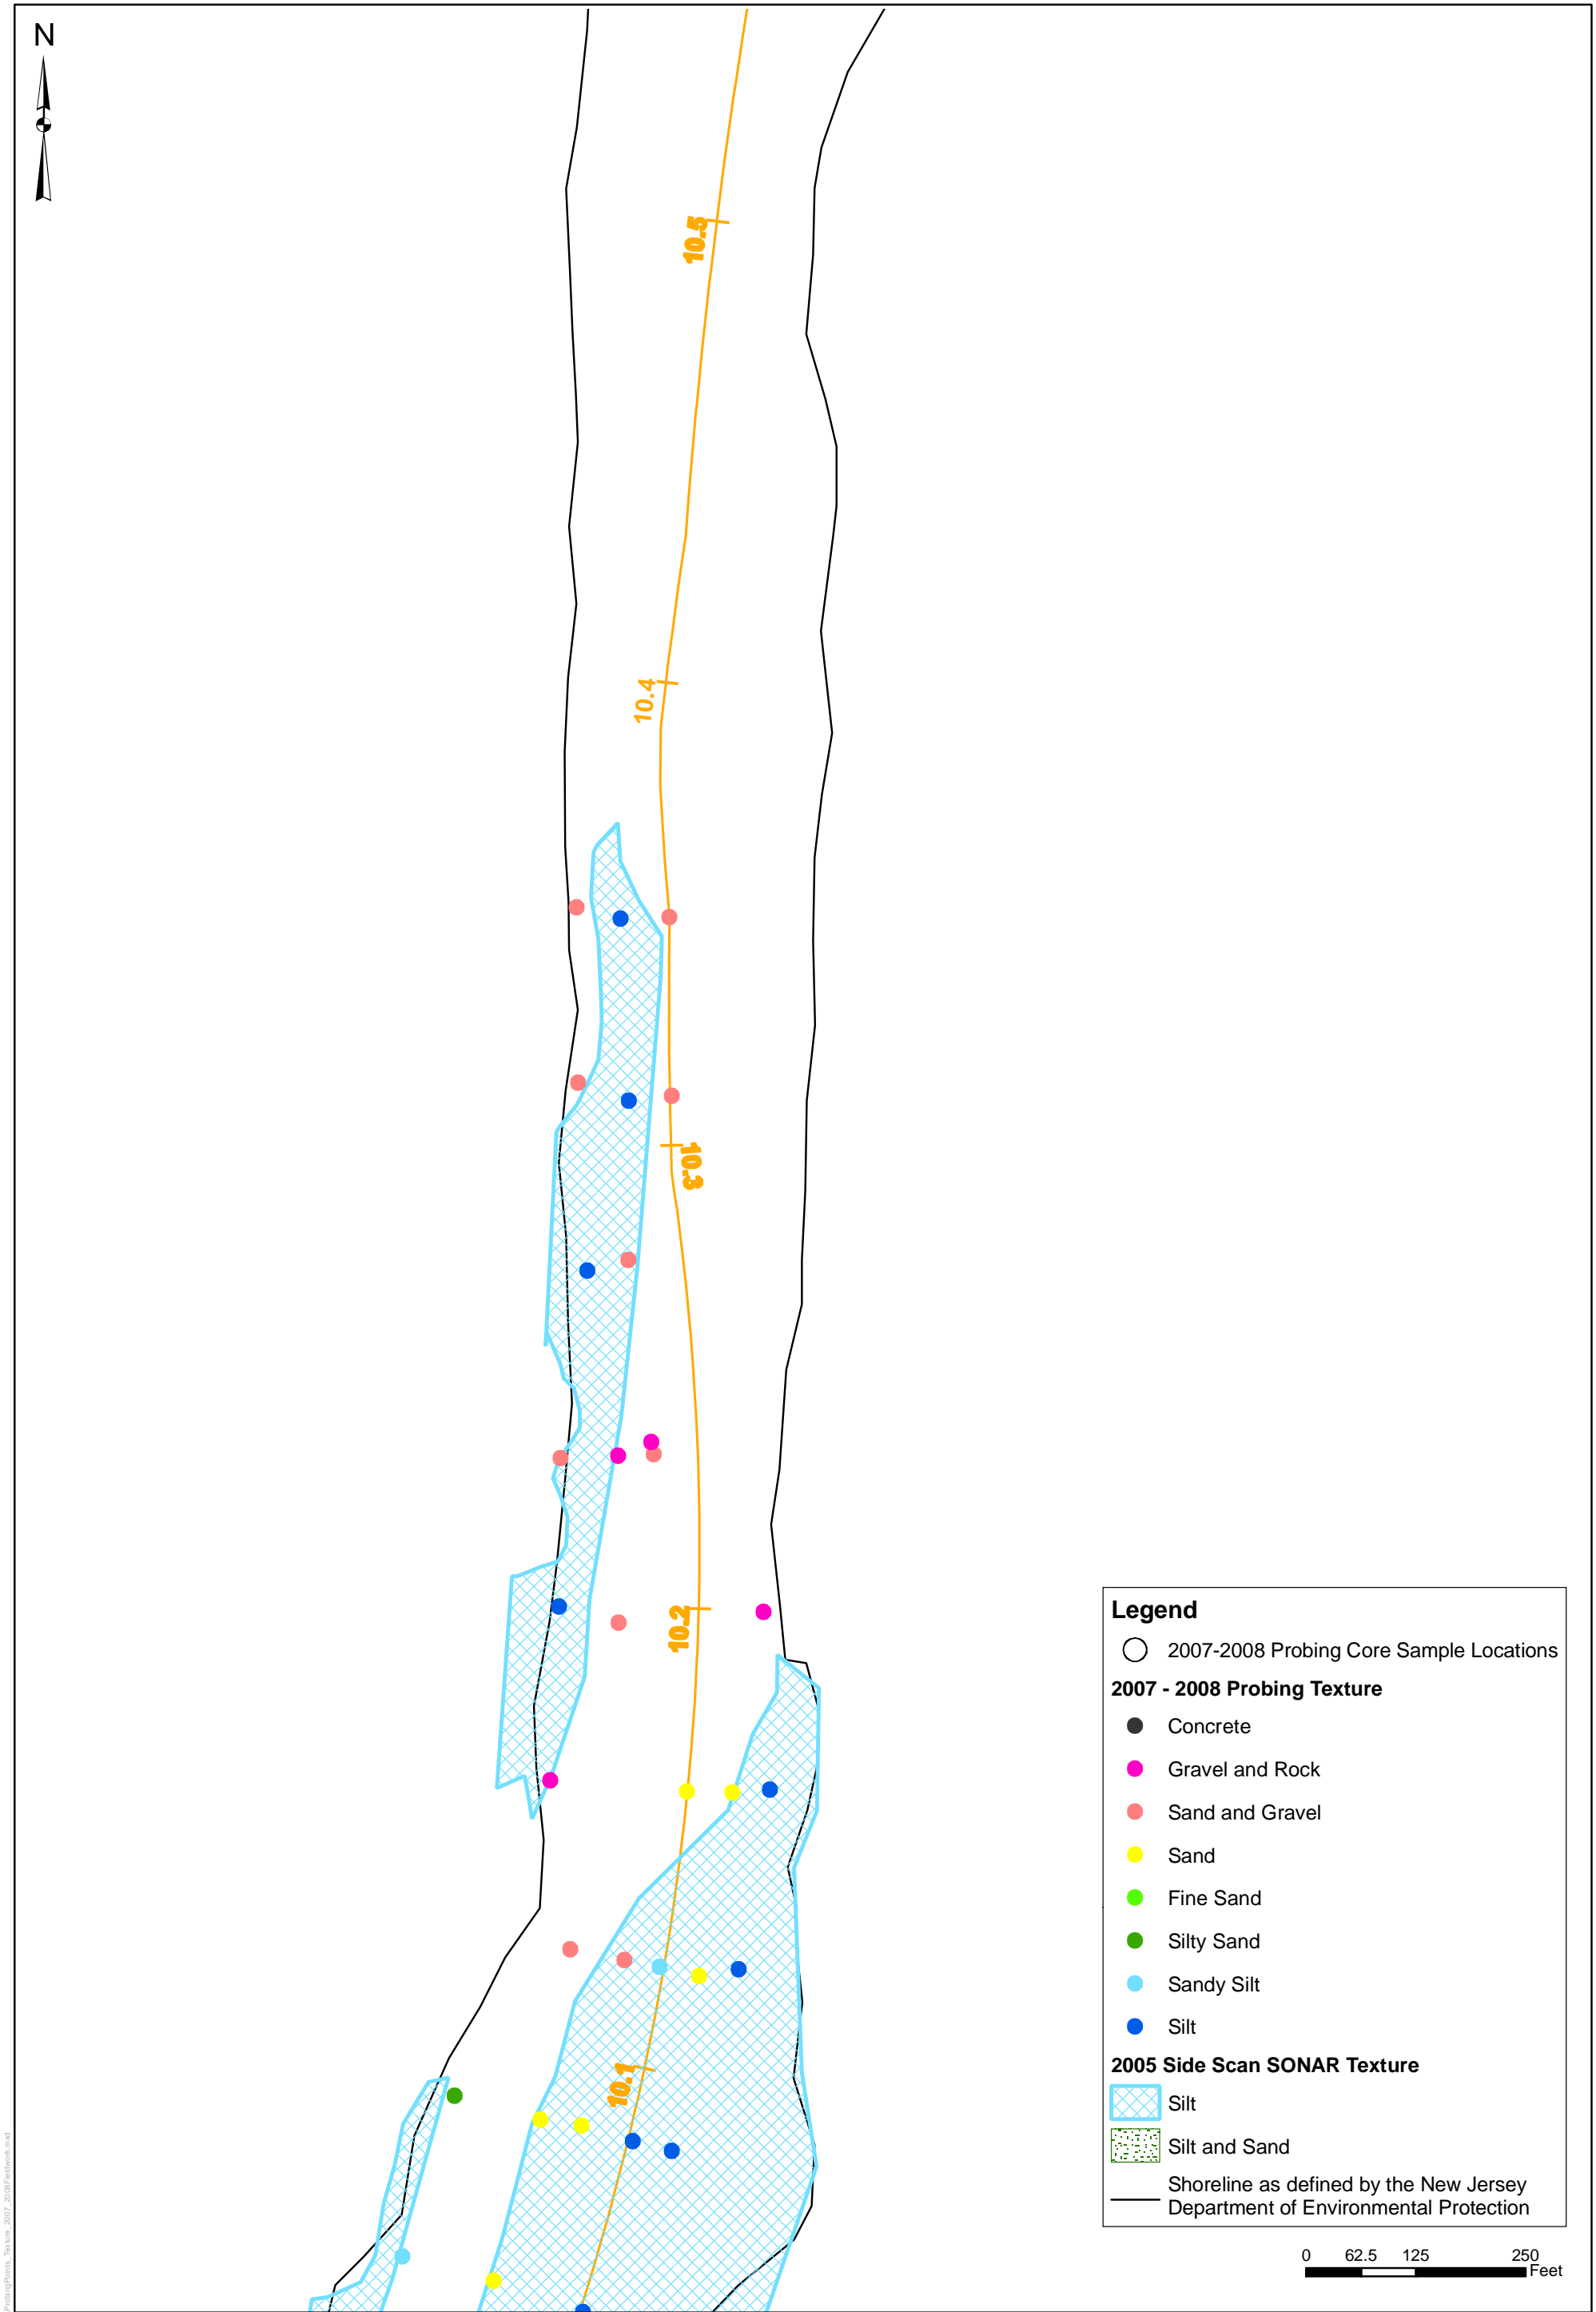
Figure B-6

Sediment Texture from Probing Above RM8
Lower Passaic River Restoration Project

Small diameter push cores were collected at every tenth location (approximately 10 percent of the locations) to confirm the data being reported from the probing. Push cores were retrieved, and sediments were classified to visually confirm what was being reported from the probing. Probing results are presented in Attachment B.

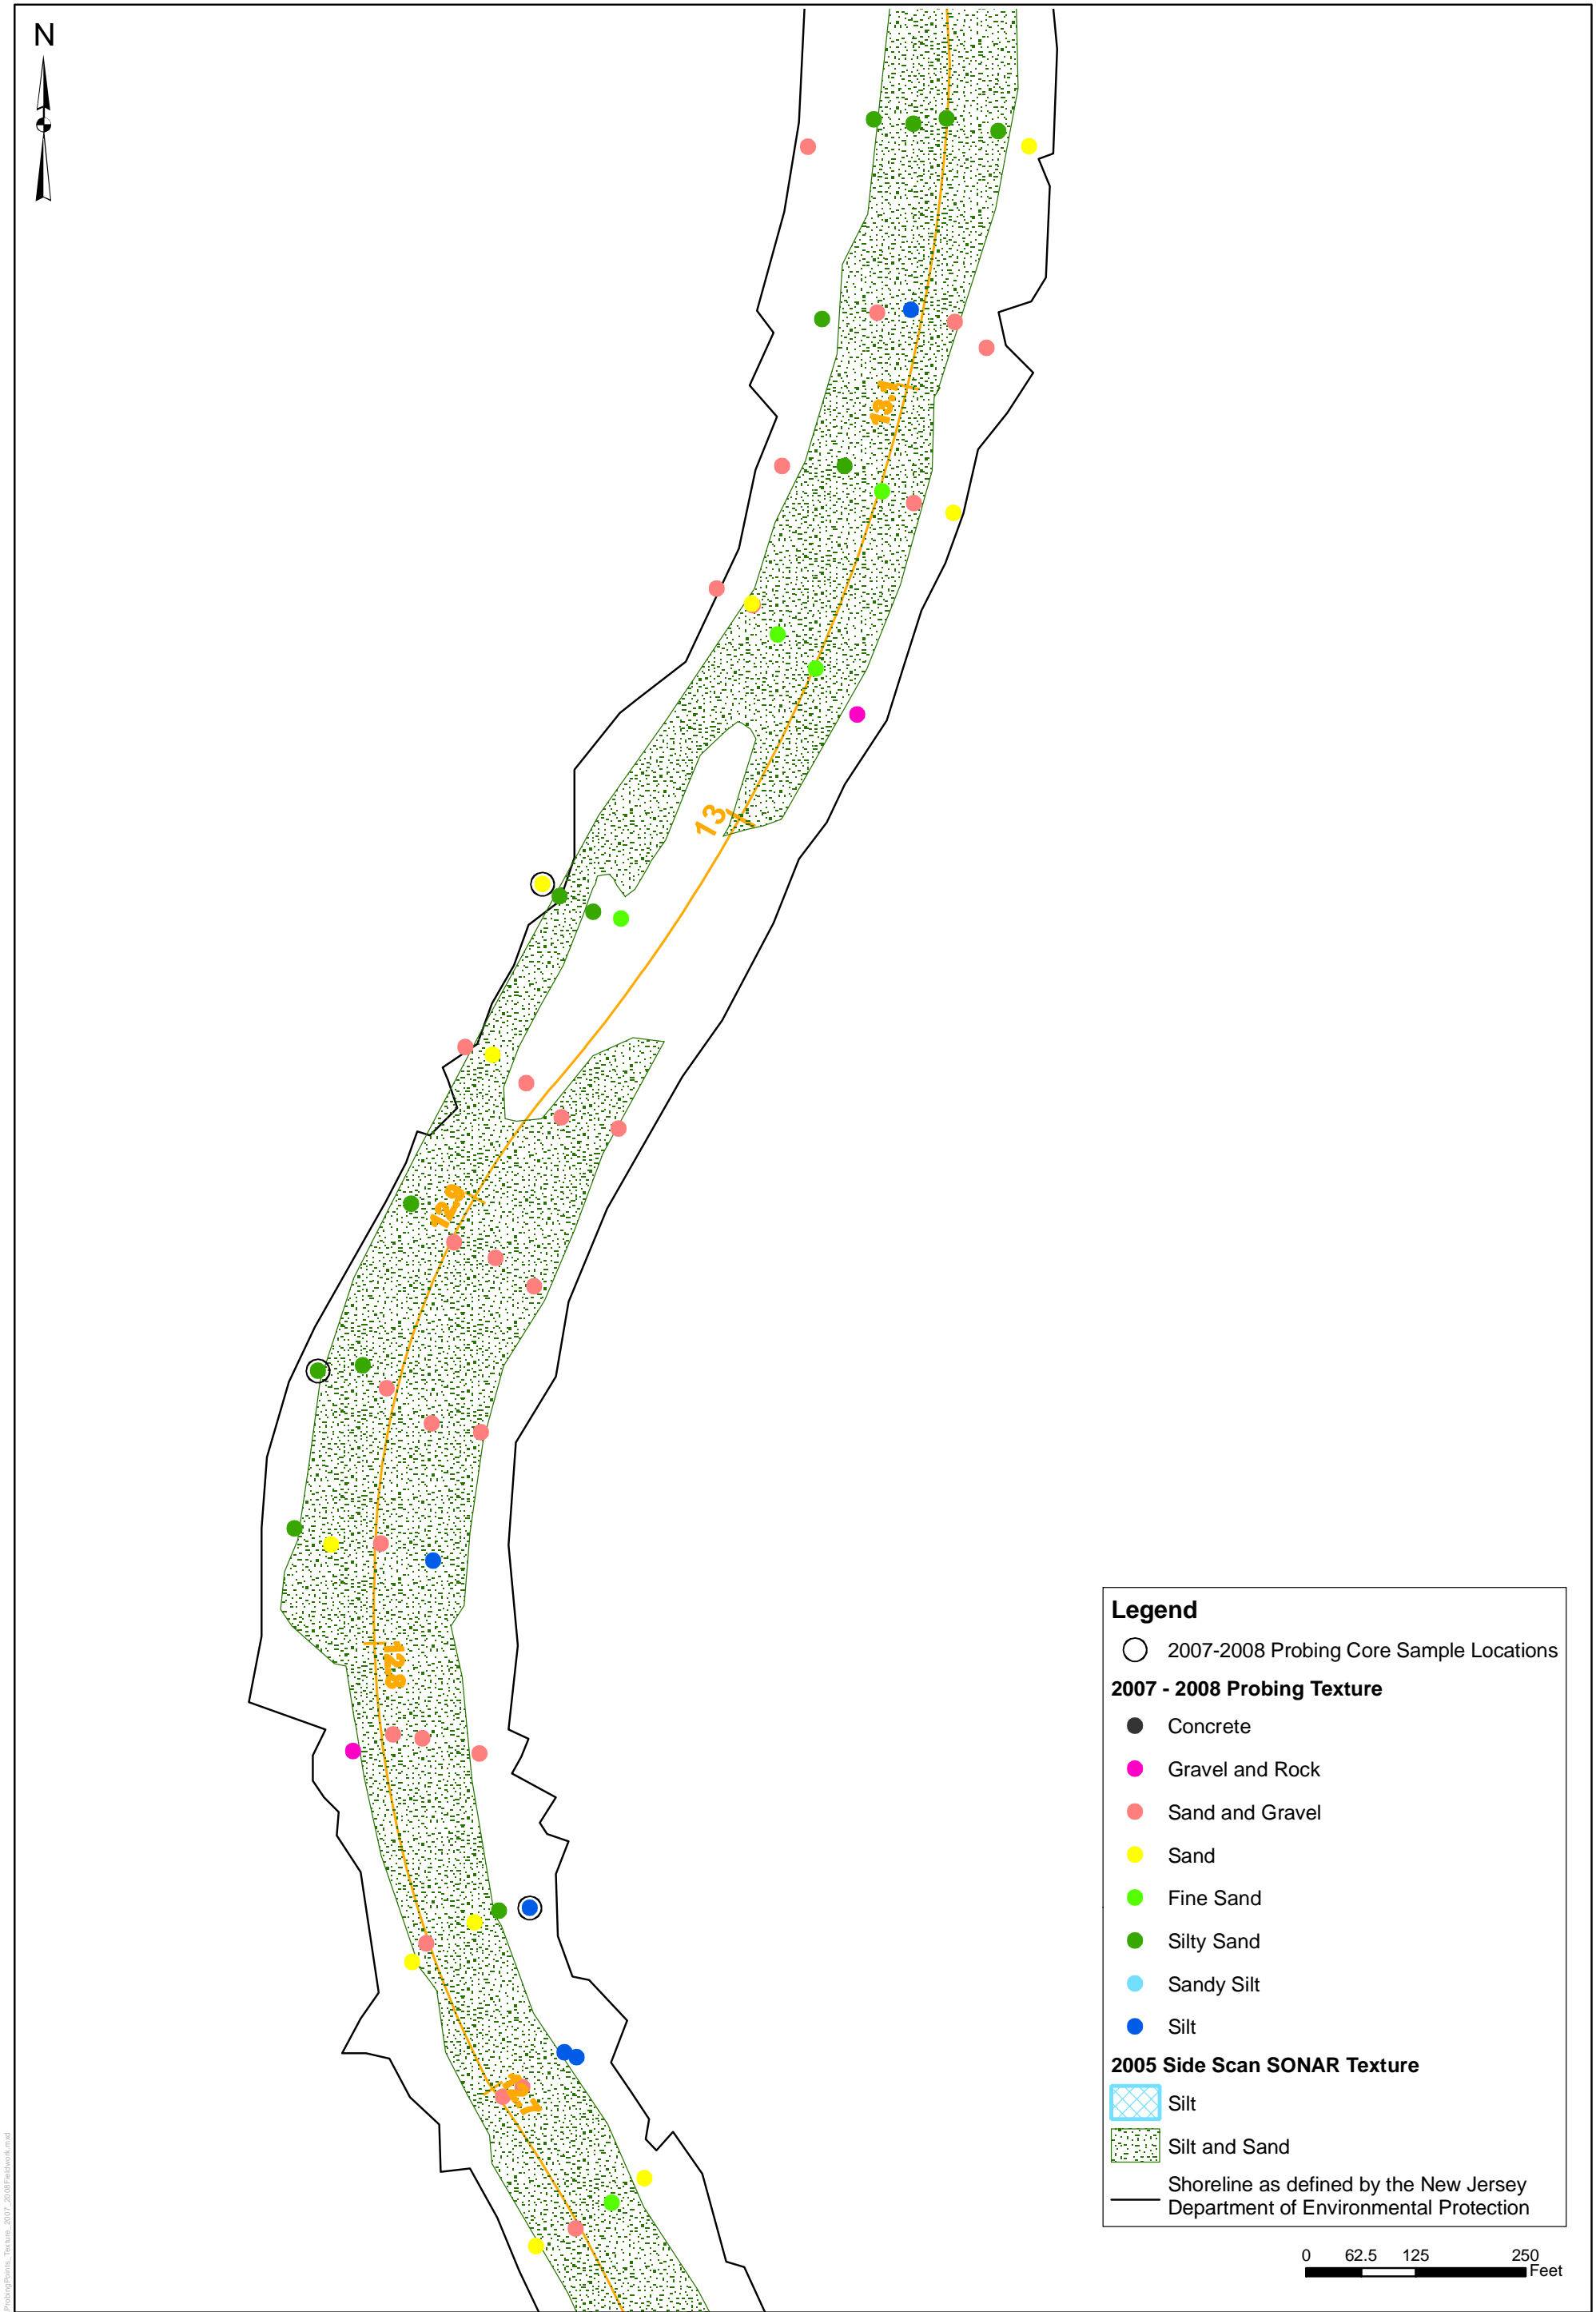
Figure B-13
August 2008

Sediment Texture from Probing Above RM8
Lower Passaic River Restoration Project

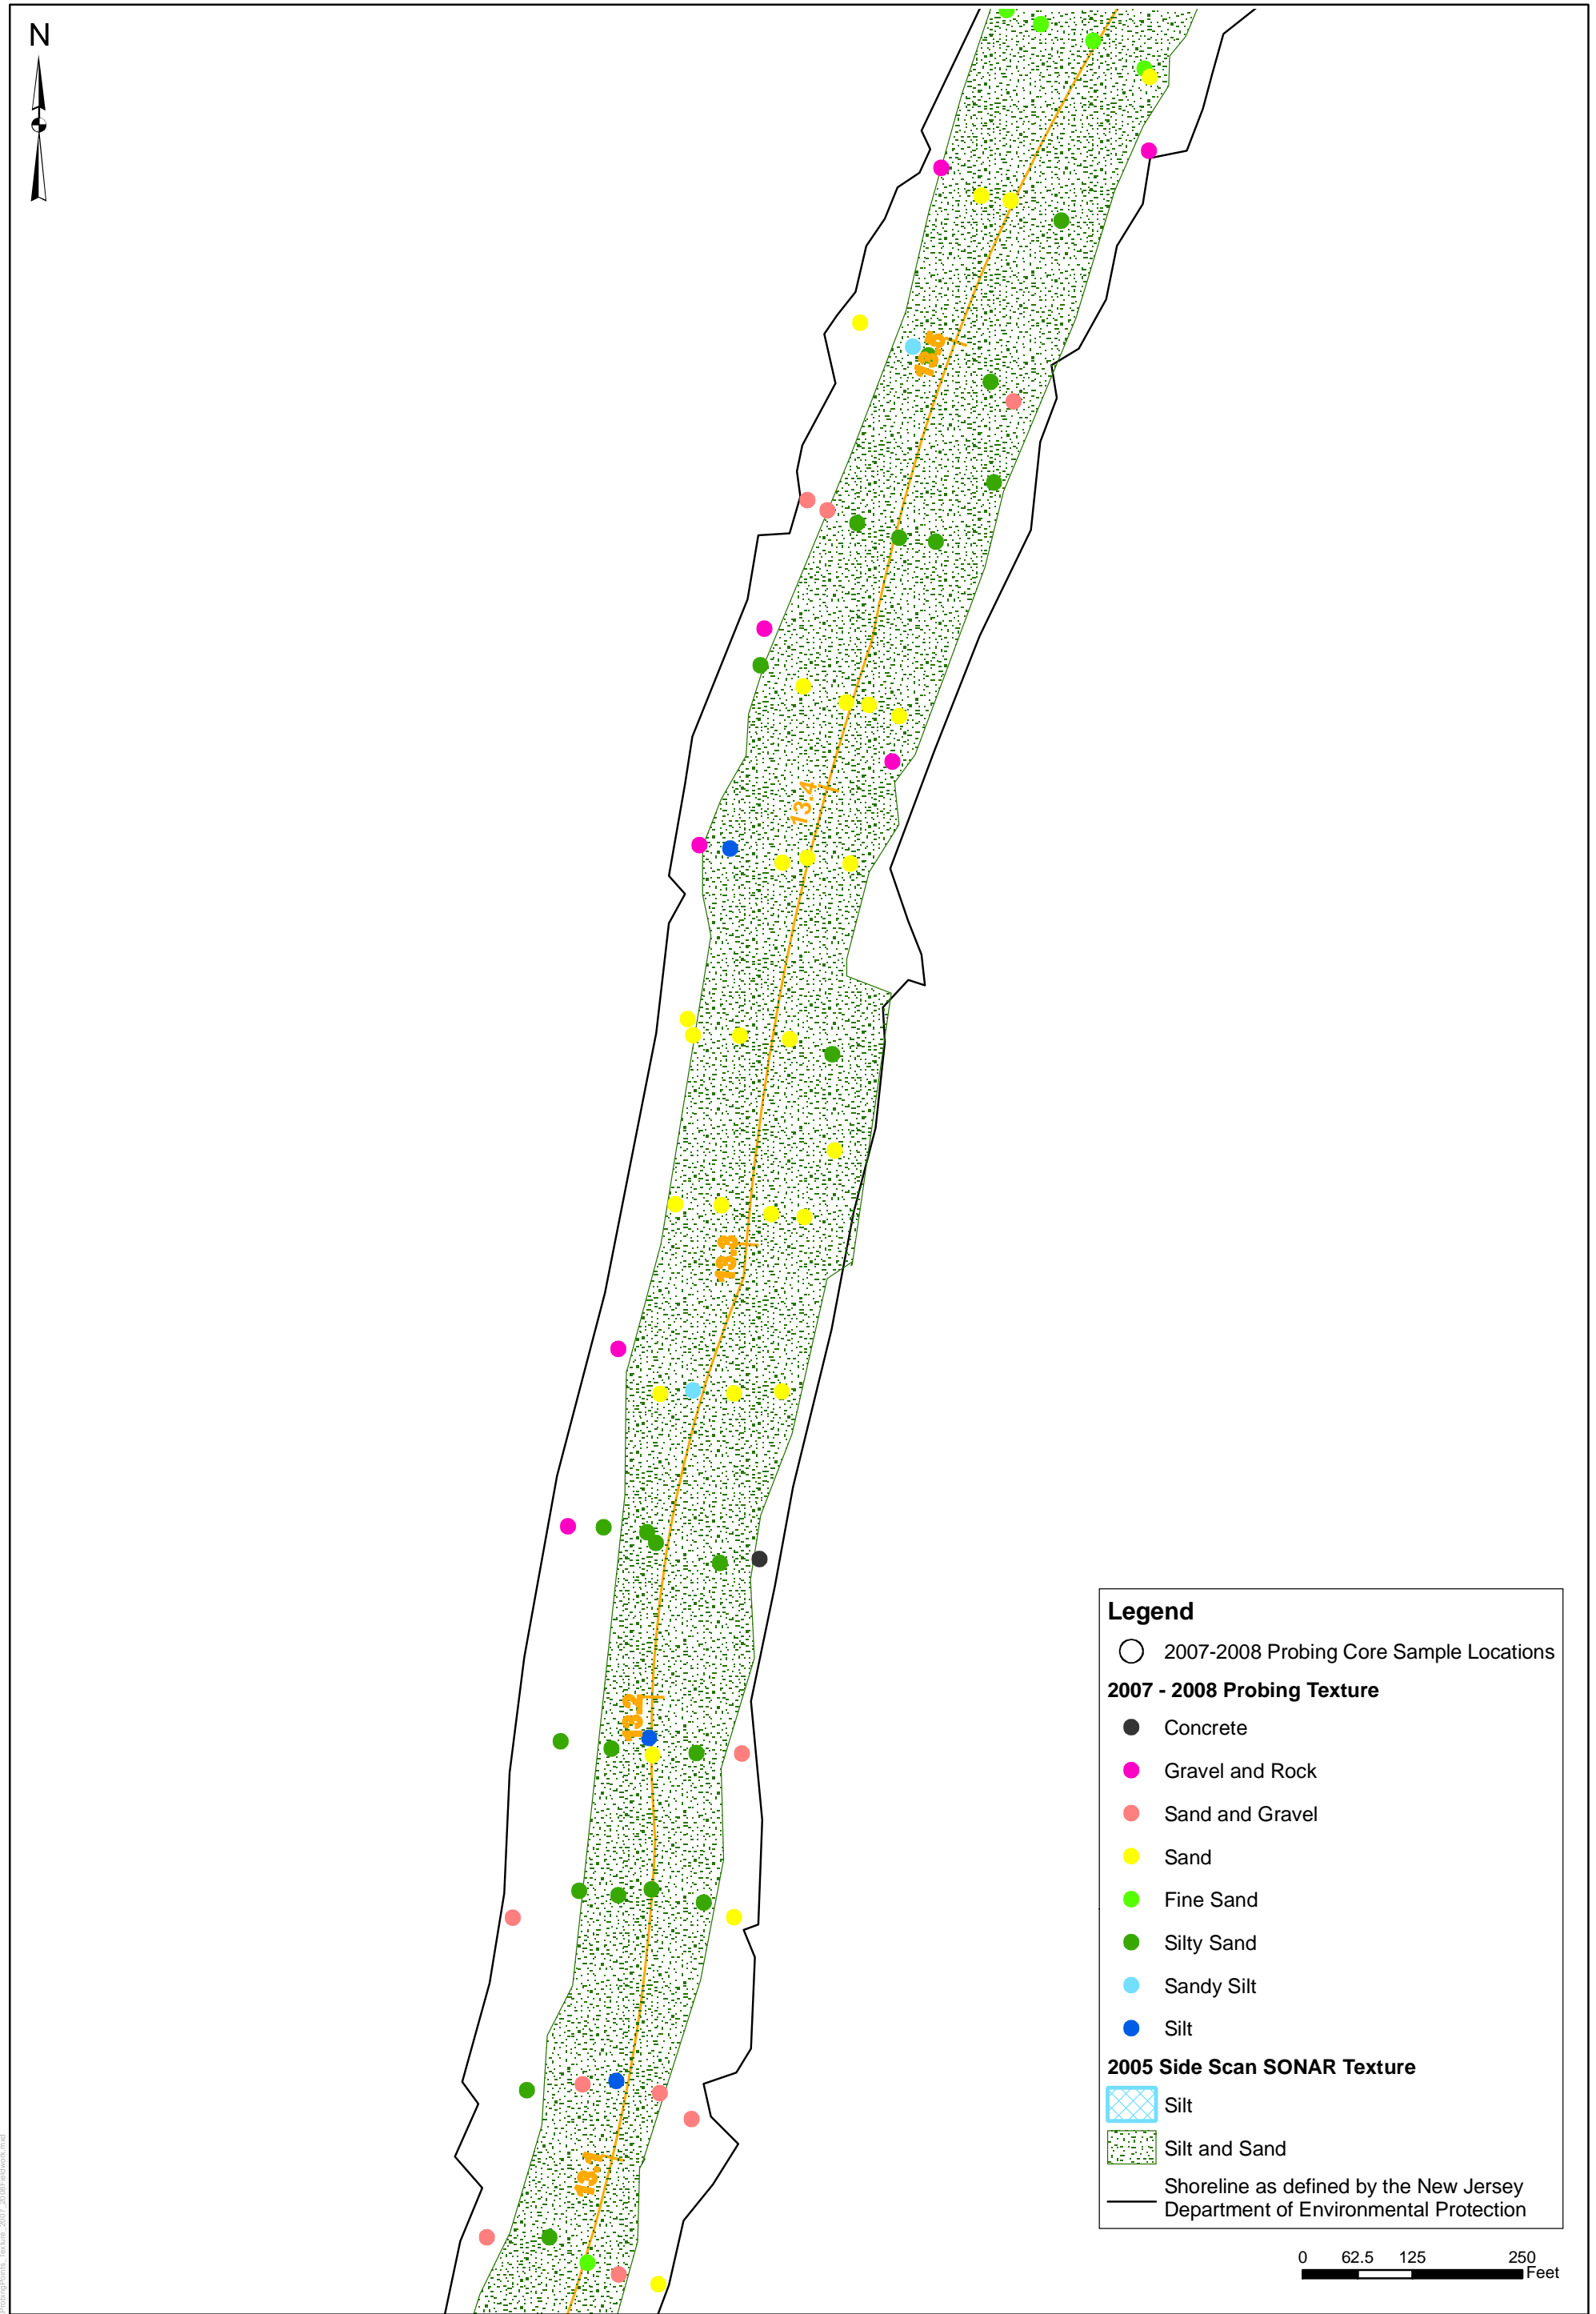
Figure B-14
August 2008

Sediment Texture from Probing Above RM8
Lower Passaic River Restoration Project
